The Moorings Condominiums
Building 8 - Club House

450 Moorings Cove Drive
Tarpon Springs, FL 34689
B.A.S.I.C. File No.: B2020-018

FINAL REPORT

Subject: Injection Pin Pile, Compaction and Chemical Grouting
The Moorings Condominiums | Building 8 – Club House
450 Moorings Cove Drive, Tarpon Springs, FL 34689

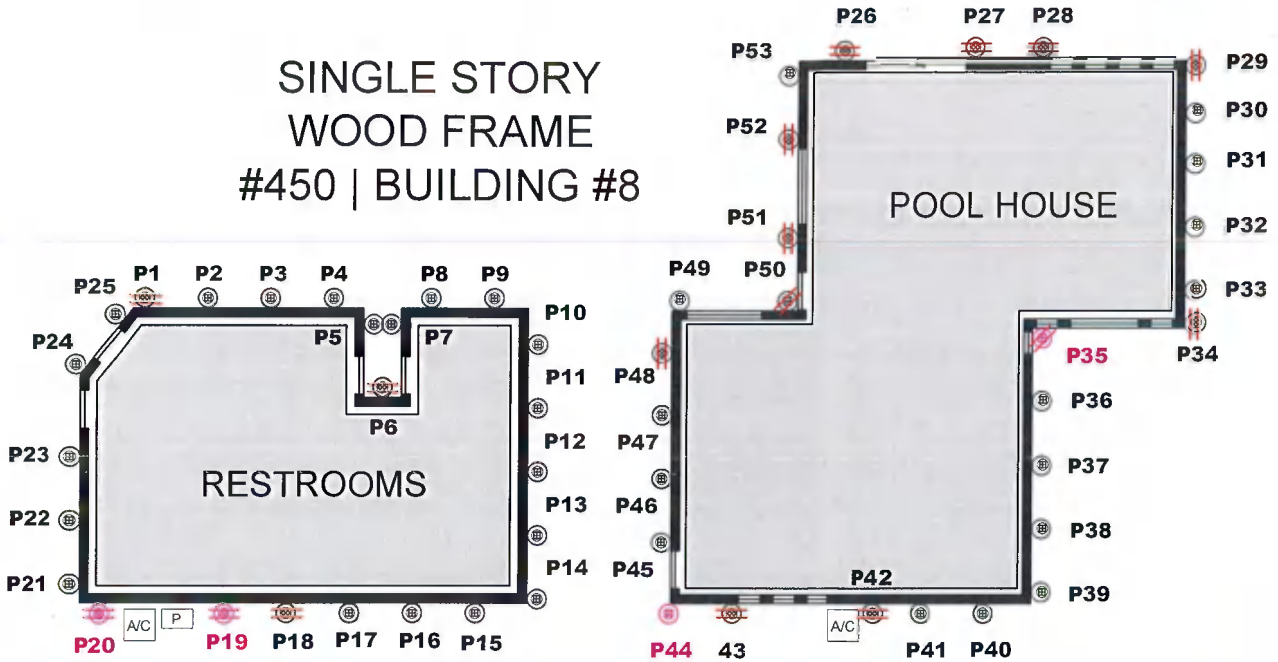
FIGURE NO.: 8a

Helicon installed a total of 49 injection pin piles around the property as per our site plan recommendations, as shown in figure 8a. Due to the site conditions, four (4) points were omitted from our original recommendations. (Injection Pin Pile Numbers 19, 20, 35 and 44). The depths of installation ranged from a low of 28 feet to a high of 63 feet below grade. Each pin pile was hydraulically driven into the soil until enough pressure was reached for refusal. The hydraulic gauge reading (psi) was recorded for each injection pin pile along with the installed depth (Figure 8a). The contractor then accepted delivery of a 1500-psi pressure grout from Pasco Ready Mix. The grout was a high slump 4-6 inch pressure grout. A grout gun was connected to each of the 49 injection pin piles pumped by Helicon, utilizing a TK-40 pump. The grout was pumped until a pressure gauge reading of up to 400-psi was reached on the in-line gauge. The amount of grout pumped for each injection pin pile was recorded (Figure 8a). A total of 100.83 cubic yards of grout was pumped in various quantities through 49 injection pin piles points.

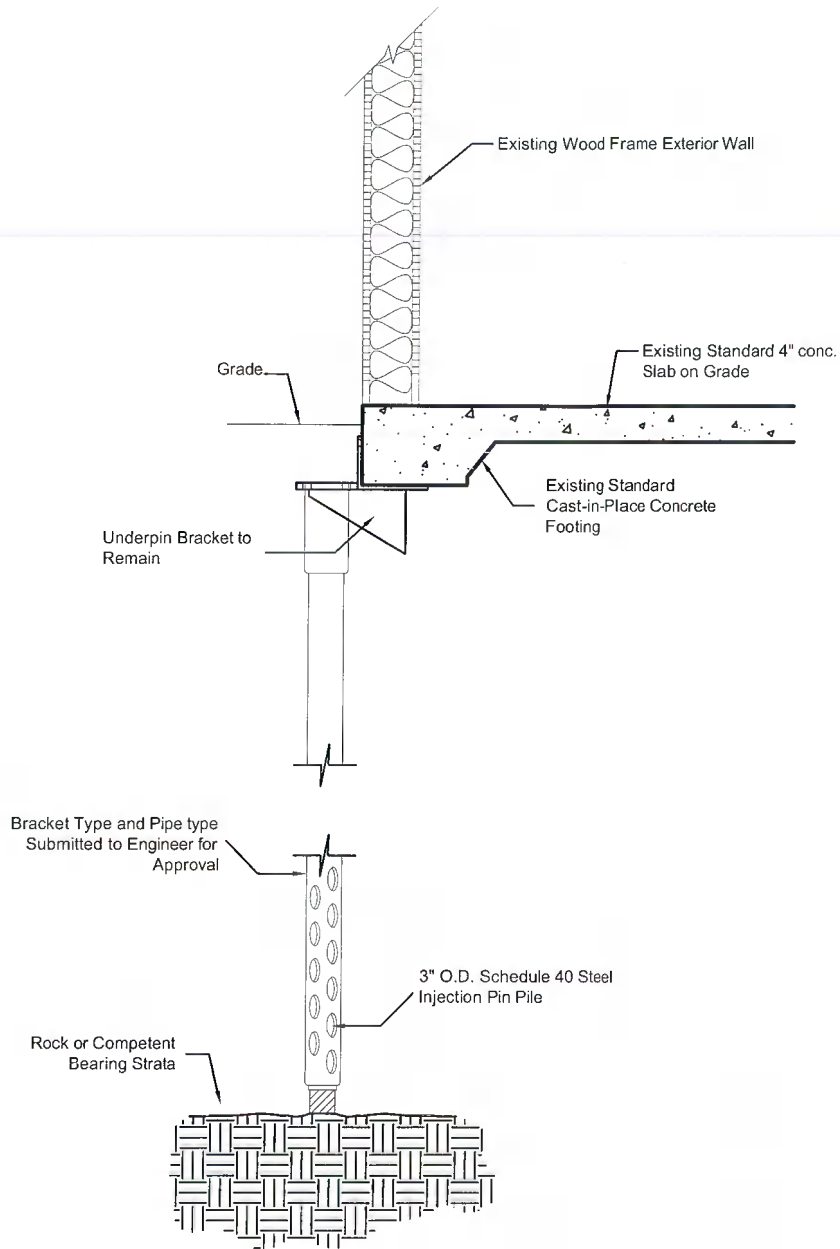
Wood Frame on Spread Footer:
Injection Pin Pile Detail
 (NOT FOR PERMITTING)

Injection Pin Piles are recommended in similar situations whereby the property requires lifting or other foundation support in addition to sealing off the limestone interface to prevent future sinkhole activity from occurring. The installation of the Injection Pin Piles is a process whereby high carbon steel pilings are hydraulically driven into the ground until a predetermined pressure reading is attained or refusal occurs where lifting of the structure takes place. The Injection Pin Piles are then grouted through a patented process allowing grout to be pumped directly at the limestone interface (Figures 8a and 8b).
