The Moorings Condominiums Building 4

350 - 364 Moorings Cove Drive
Tarpon Springs, FL 34689
B.A.S.I.C. File No.: B2020-018

FINAL REPORT

Subject: Injection Pin Pile, Compaction and Chemical Grouting
The Moorings Condominiums | Building 4
350 – 364 Moorings Cove Drive, Tarpon Springs, FL 34689

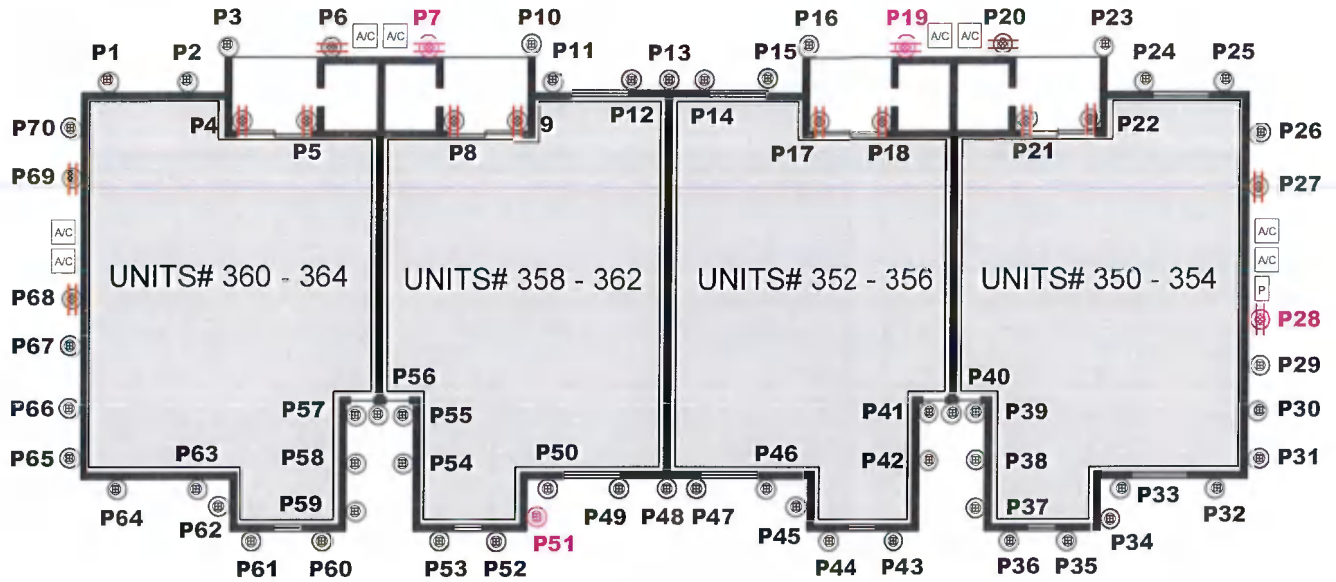
FIGURE NO.: 4a

Helicon installed a total of 66 injection pin piles around the property as per our site plan recommendations, as shown in figure 4a. Due to the site conditions, four (4) point were omitted from our original recommendations. (Injection Pin Pile Numbers 7, 19, 28 and 51). The depths of installation ranged from a low of 5 feet to a high of 160 feet below grade. Each pin pile was hydraulically driven into the soil until enough pressure was reached for refusal. The hydraulic gauge reading (psi) was recorded for each injection pin pile along with the installed depth (Figure 4b). The contractor then accepted delivery of a 1500-psi pressure grout from Pasco Ready Mix. The grout was a high slump 4-6 inch pressure grout. A grout gun was connected to each of the 66 injection pin piles pumped by Helicon, utilizing a TK-40 pump. The grout was pumped until a pressure gauge reading of up to 400-psi was reached on the in-line gauge. The amount of grout pumped for each injection pin pile was recorded (Figure 4a). A total of 28.4 cubic yards of grout was pumped in various quantities through 66 injection pin piles points.

- ⊗ - INJECTION PIN PILE
- ⊗ - SPREADER BEAM
- ⊙ - POINTS OMITTED
- SEE FIGURE 4b FOR INJECTION PIN PILE DETAIL
- NOT FOR PERMITTING

CONSTRUCTION INJECTION PIN PILE PLAN
